MSHA Report of Investigation  
 Loveridge No. 22 Mine Fire / Explosion

MSHA Report of Investigation  
Loveridge No. 22 Mine Fire / Explosion  
June 22, 1999

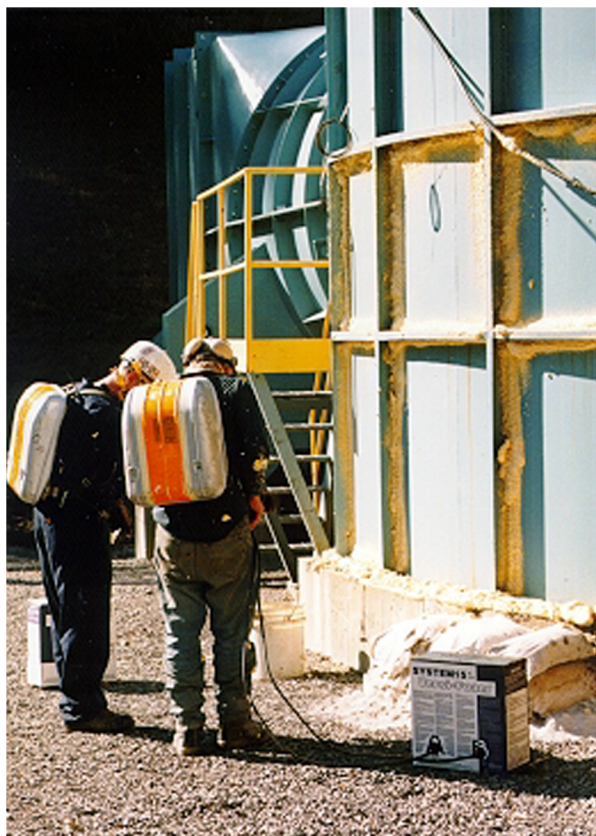
**Figure 5 (bottom left):** Mine rescue team members apply foam sealant to the St. Leo fan housing on June 22, 1999.

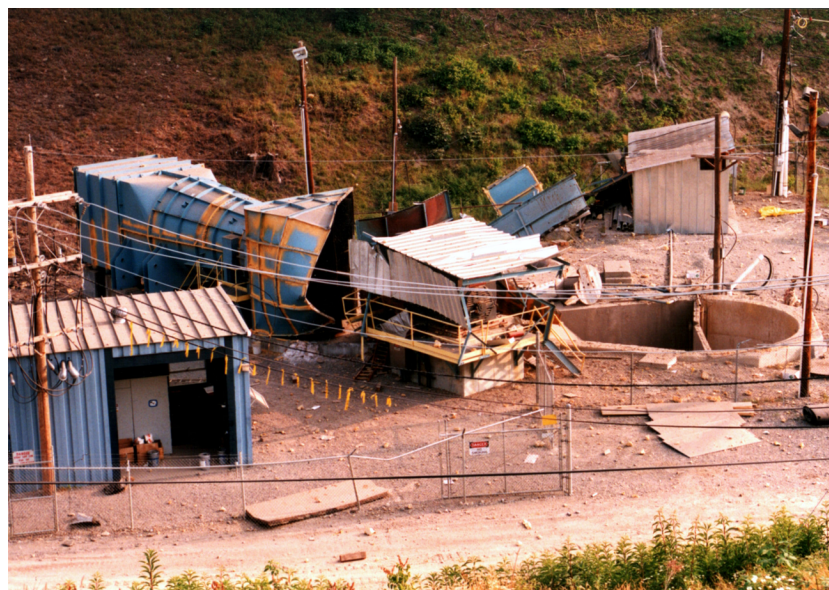
**Figure 6 (bottom right):** Damage to St. Leo fan and shaft after the explosion on June 26, 1999. The deflection of the top of the shaft partition is visible in this photograph.

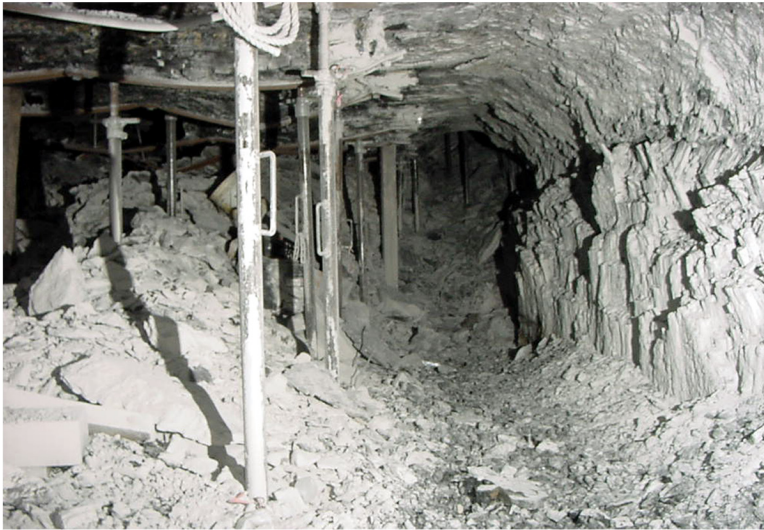
**Figure 18 (top):** A miner crawls across the top of the roof fall in the 8-North No.7 entry.

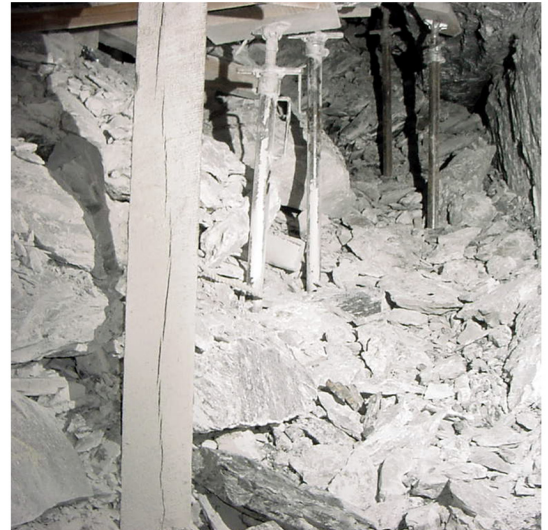
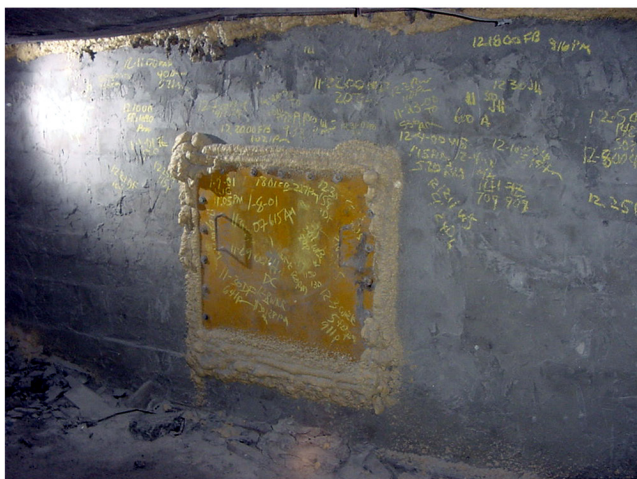
**Figures 19 & 20 (center):** Debris along the left side of the approach to the 8-North No. 7 entry roof fall illustrates the volume of material that was manually removed during the recovery efforts.

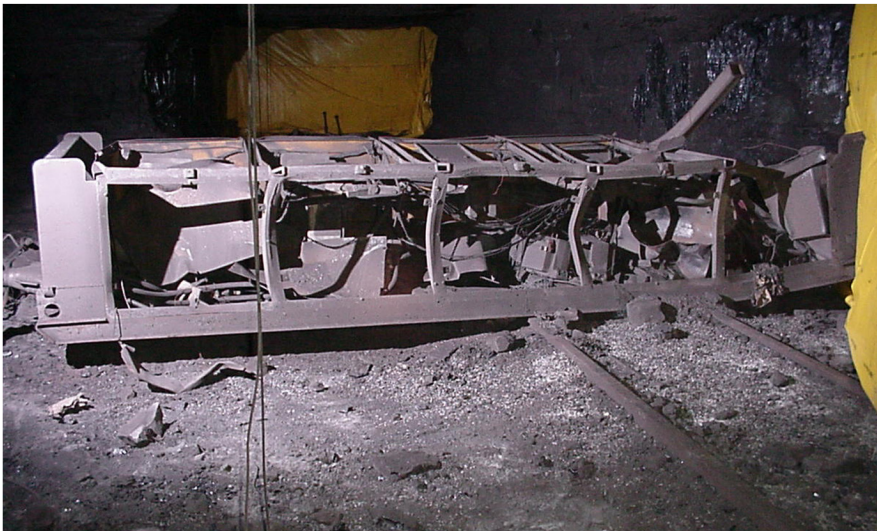
**Figure 23 (top):** This vacuum breaker box was thrown by explosive forces from the crosscut, on the right side of this picture, and deposited on the track where it was hit by additional forces from an inby direction (photo taken while facing outby in the track entry).

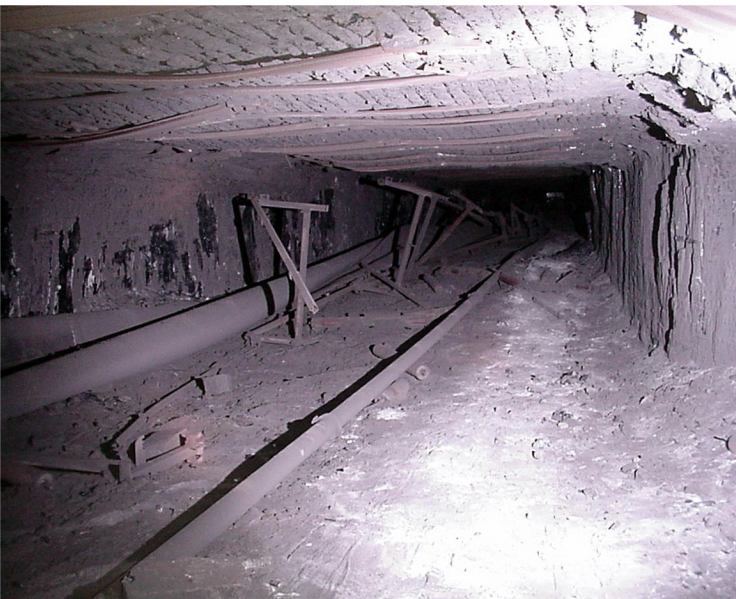
**Figure 24 (center left):** The smaller temporary belt was rolled away from the track entry (photo looking outby).

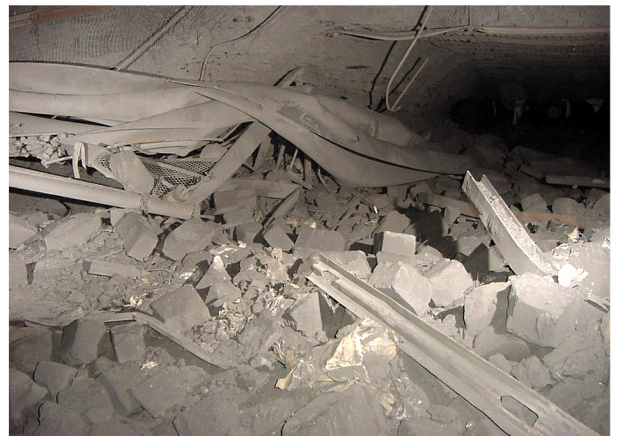
**Figure 25 (center right):** Damage to belt structure at an overcast.

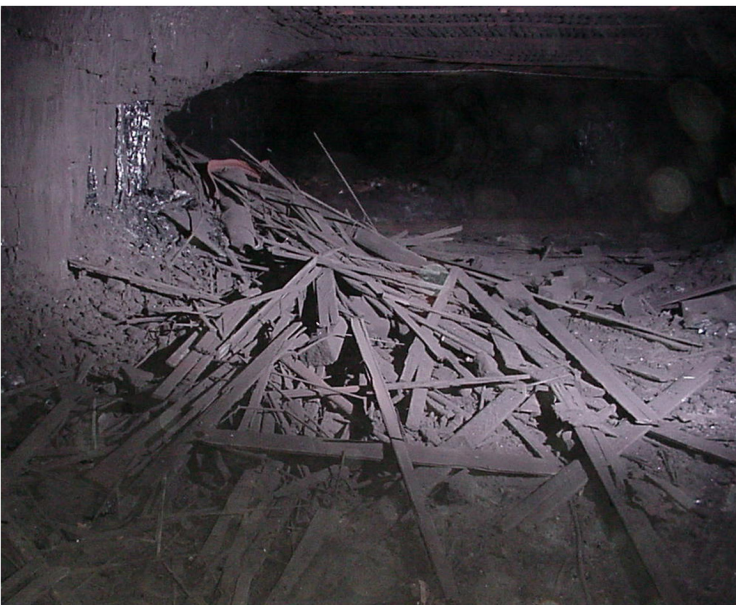
**Figure 26 (bottom left):** Destroyed fire fighting station.

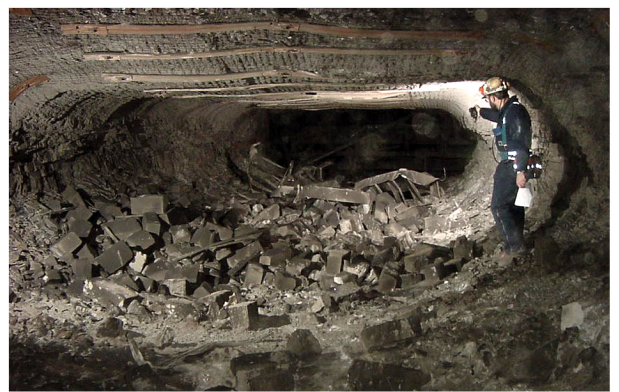
**Figure 27 (bottom right):** Investigation team surveys damage to ventilation controls.

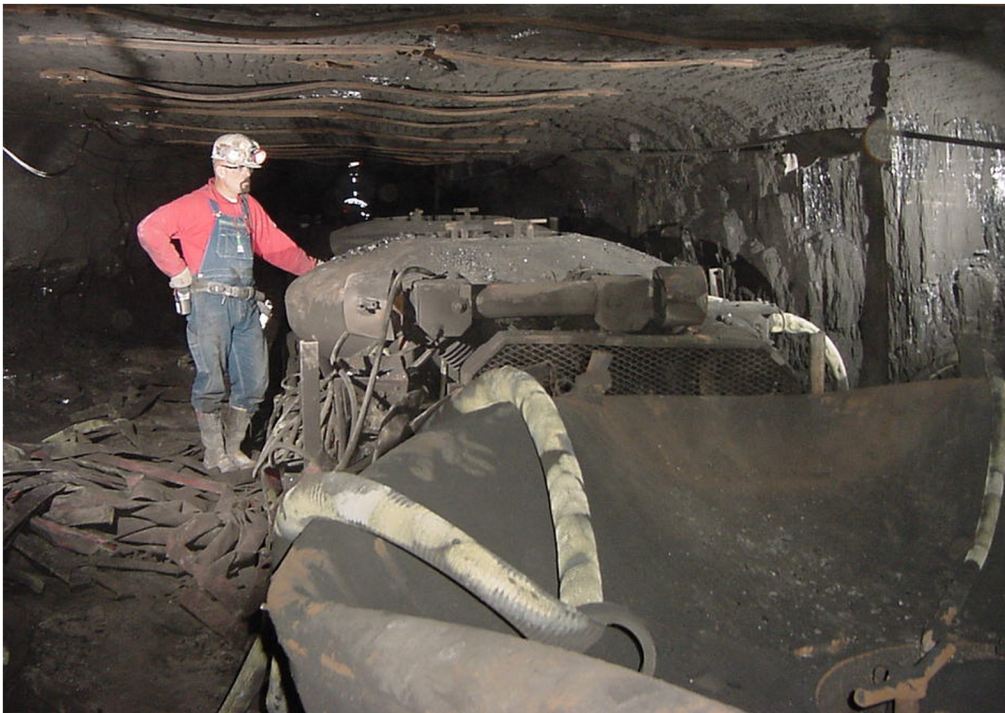
**Figure 28 (top):** A miner observes the rock dust pods located near Crosscut 21 in the 9-South track entry. The steel pod in the foreground was imploded, while that nearest the miner remained intact.

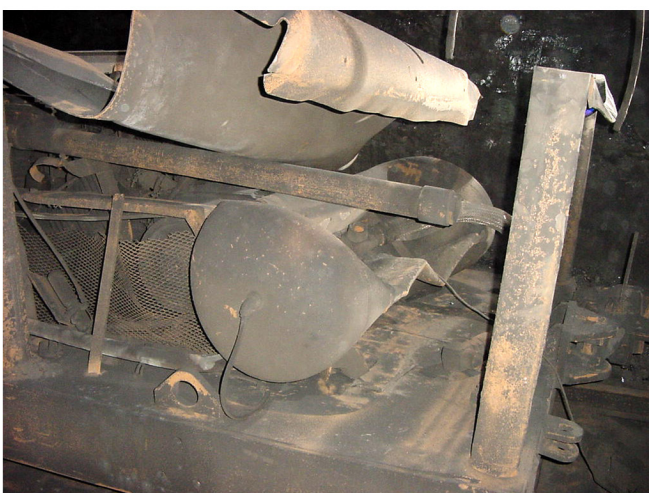
**Figure 31 (bottom):** Air compressor tank on a rock dusting machine, located at the end of the 9-South track entry.

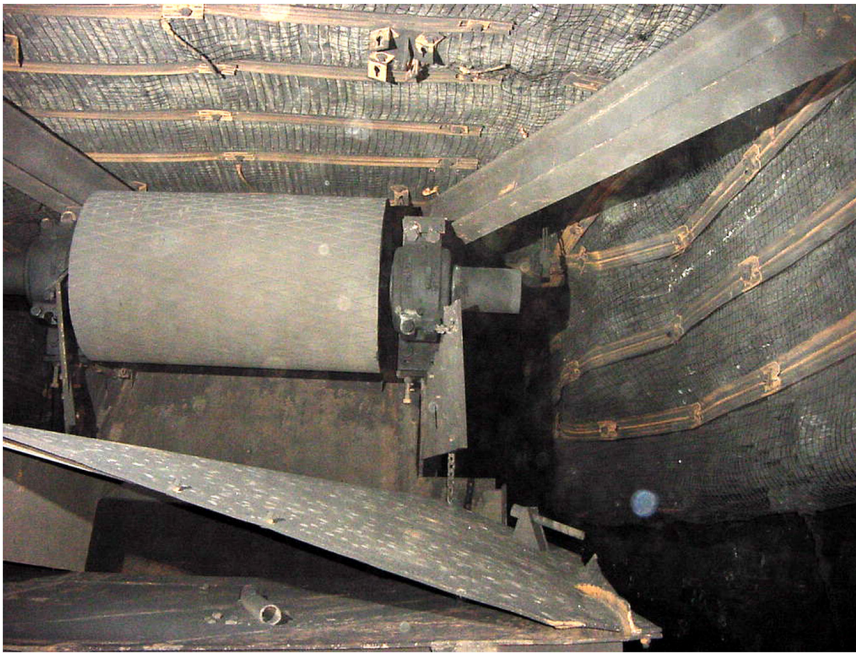
**Figure 32 (top):** Head roller assembly that was being installed at the junction of the 3D and 9-South belt entries. The roof elevation in the adjacent 9-South belt entry is visible in the lower right corner of this image.

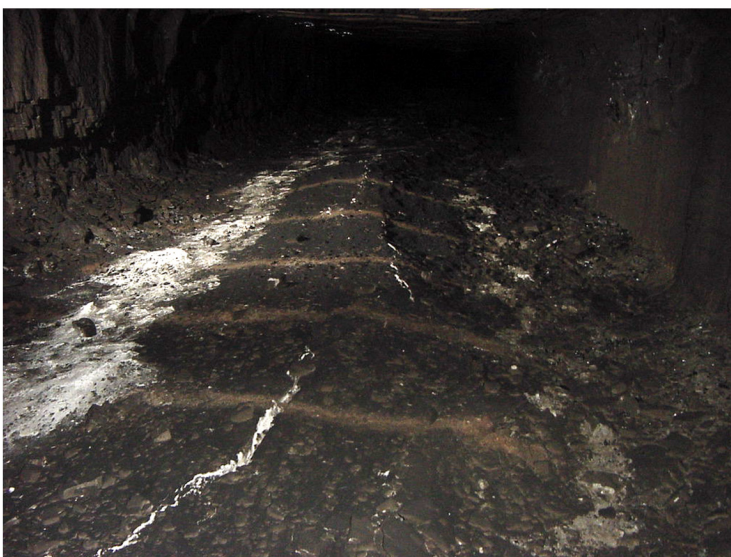
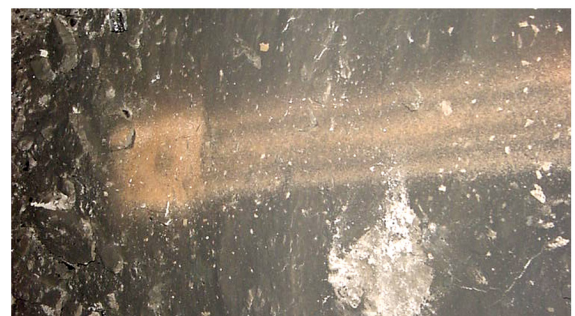
**Figures 35-36 (bottom):** Rust particles deposited on the mine floor. These particles dropped 6-7 feet from rusting roof bolt channels, forming detailed images of the channels on the floor throughout 9-South. This indicated that there was no natural ventilation in the submain after the explosion.

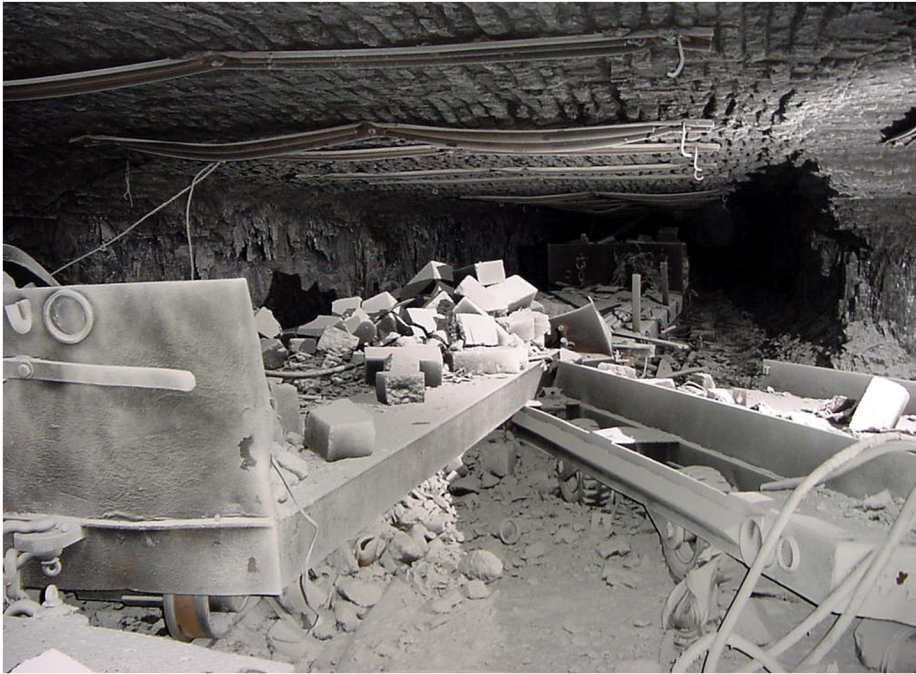
**Figure 39 (top):** Cable car blown into supply cars by forces from the adjacent belt entry to the right.

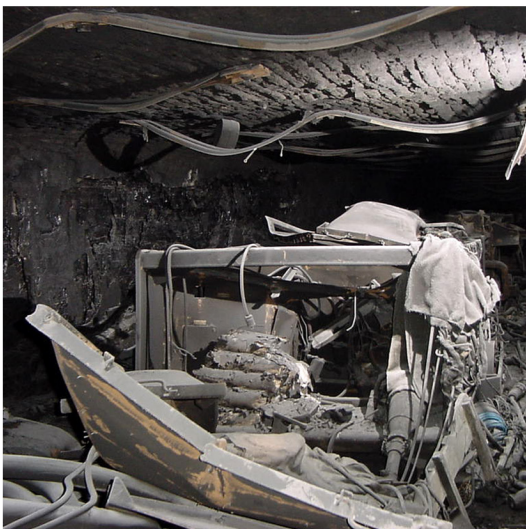
**Figure 40 (center left):** Damaged power car near the end of the track.

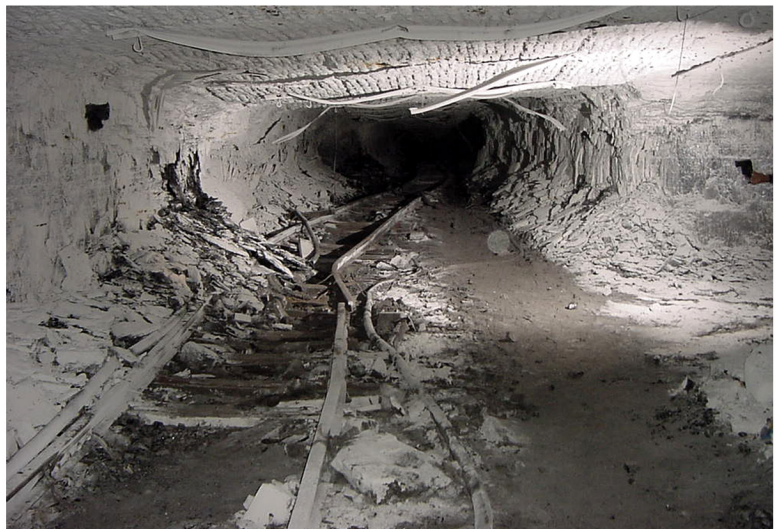
**Figure 41 (center right):** The track was displaced and rail was broken by forces from the adjacent belt entry.

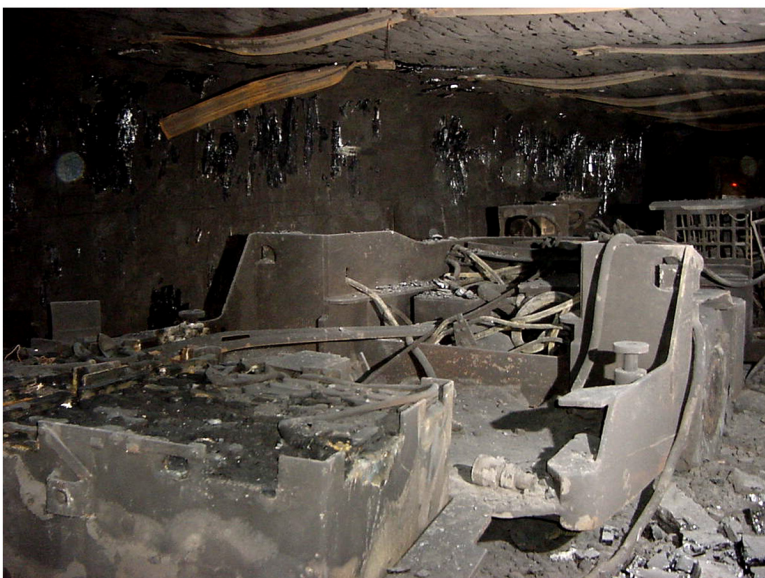
**Figure 42 (bottom left):** Batteries blown off of scoop.

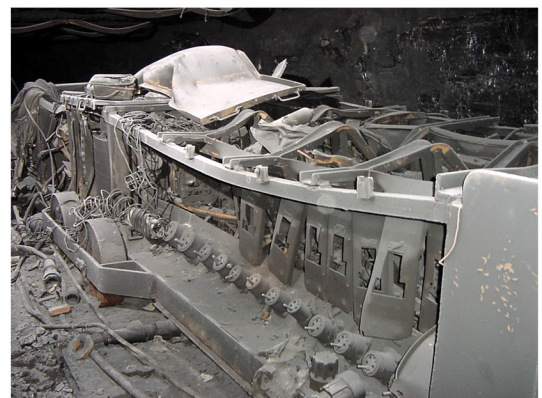
**Figure 43 (bottom right):** Damaged power car (same as Figure 40)

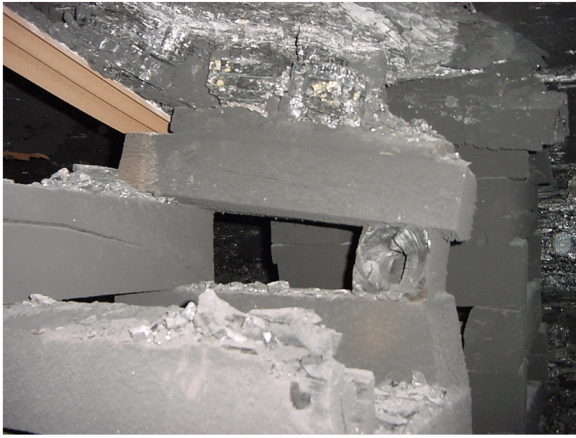
**Figure 45 (top):** Burned roof coal and cribbing adjacent to a roof fall near the fire origin.

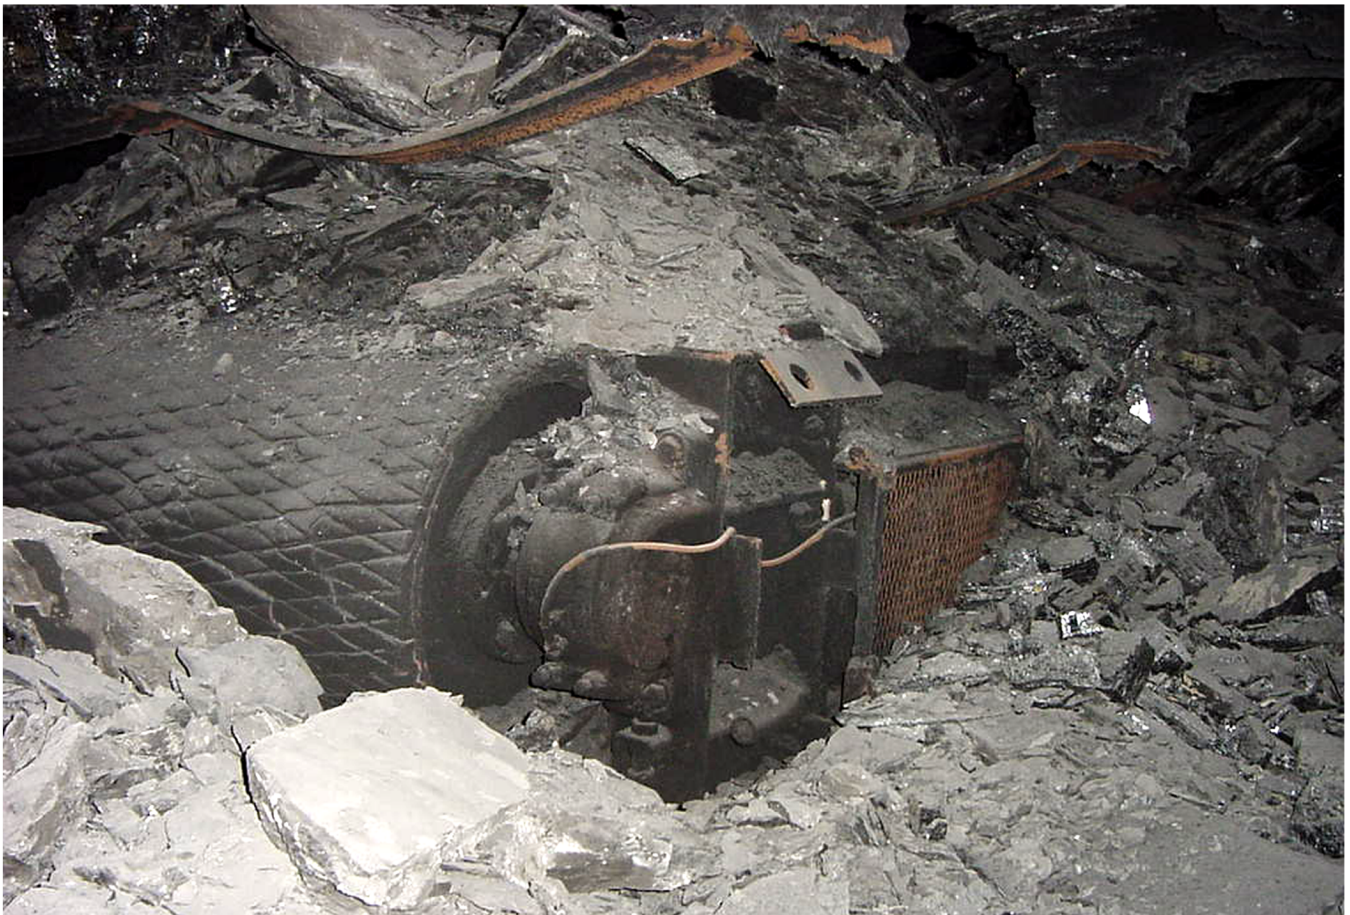
**Figure 46 (center):** Roof fall covering a scoop that was loaded with the last section of the belt take-up following cutting operations.

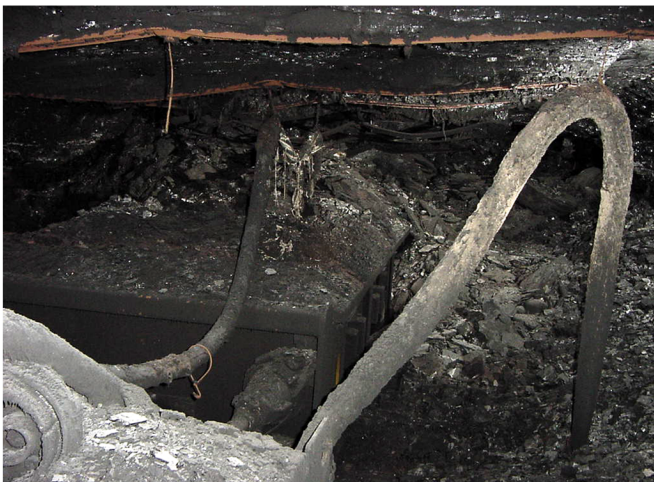
**Figure 47 (bottom left):** Power centers located in the 8-North entries, just outby the fire origin.

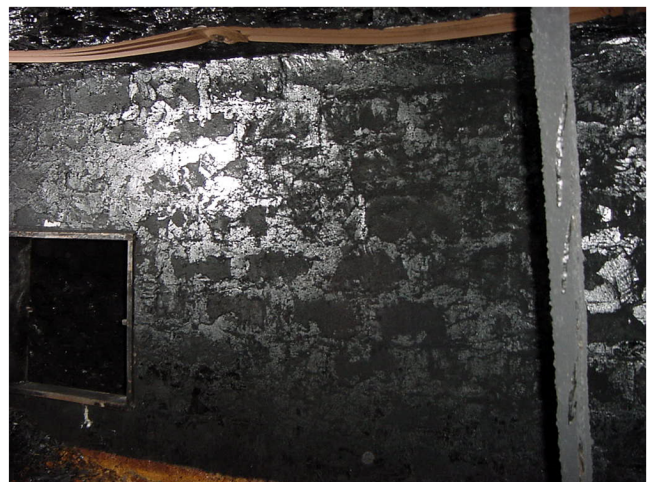
**Figure 48 (bottom right):** Soot deposits a stopping in the return entry immediately downwind of the fire origin.
